APPENDIX F – Code Enforcement List of Deficiencies

17 N Riverview Exterior Property Assessment – Code Enforcement

27 N Riverview Exterior Property Assessment – Code Enforcement

40 N Blacksmith Exterior Property Assessment – Code Enforcement

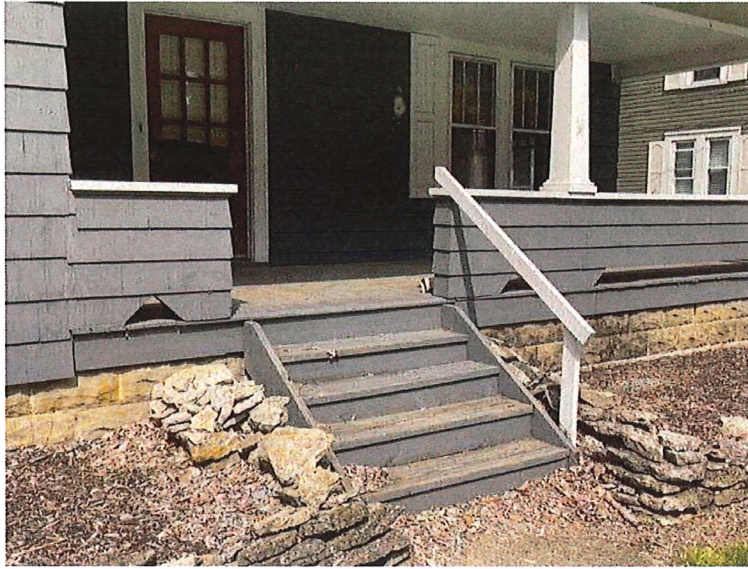
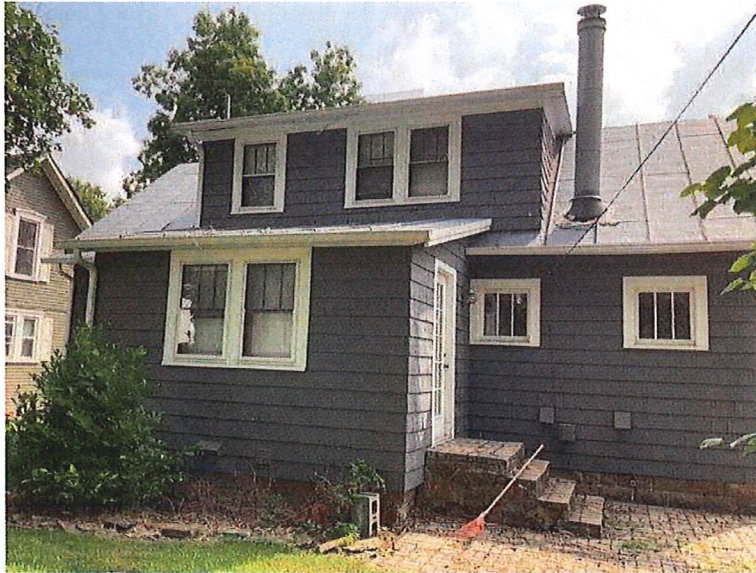
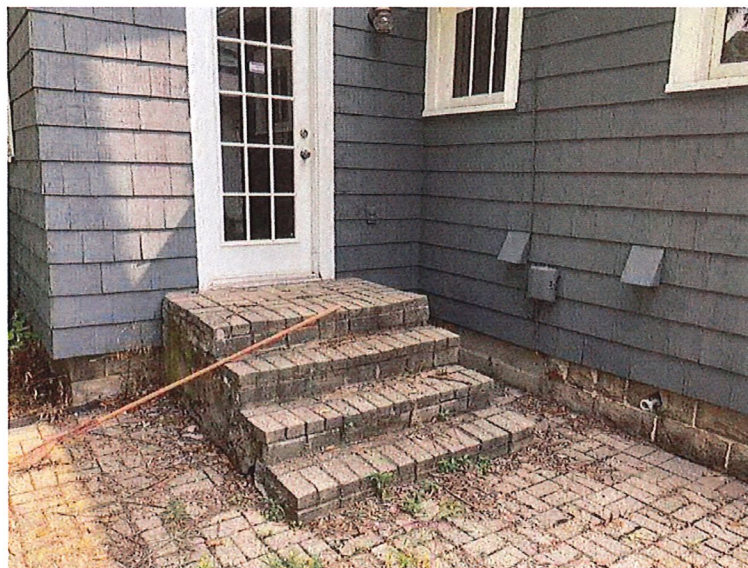
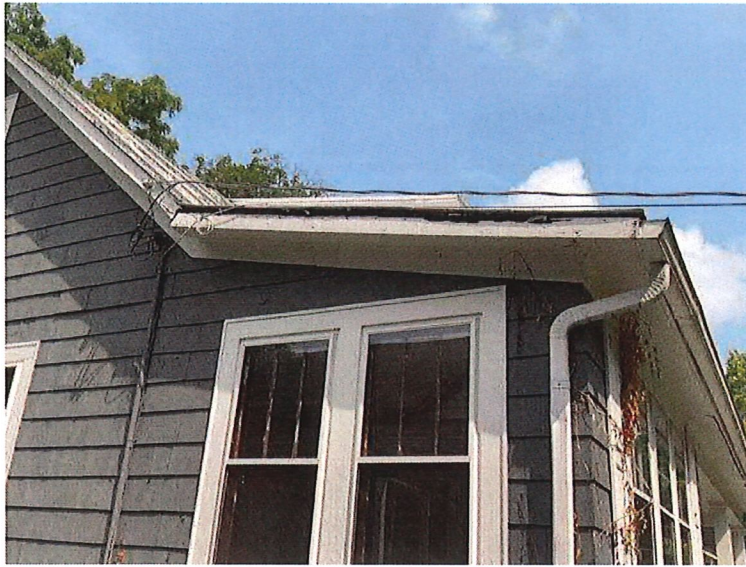
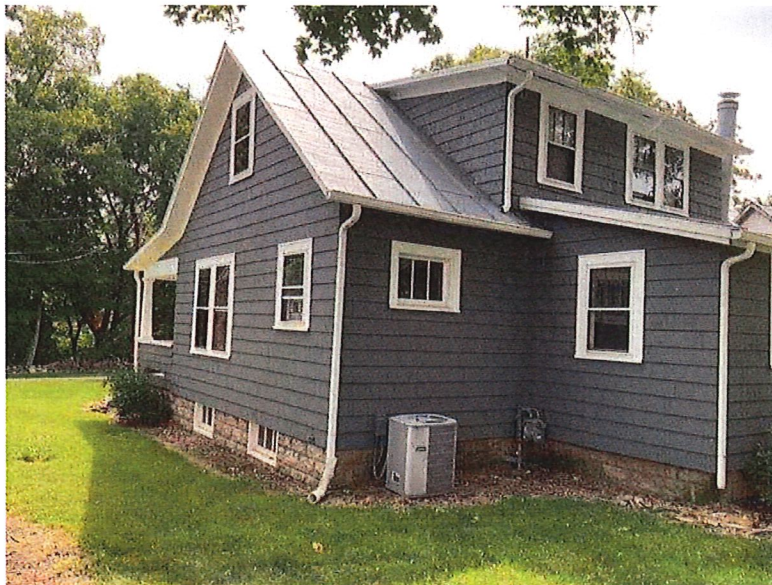
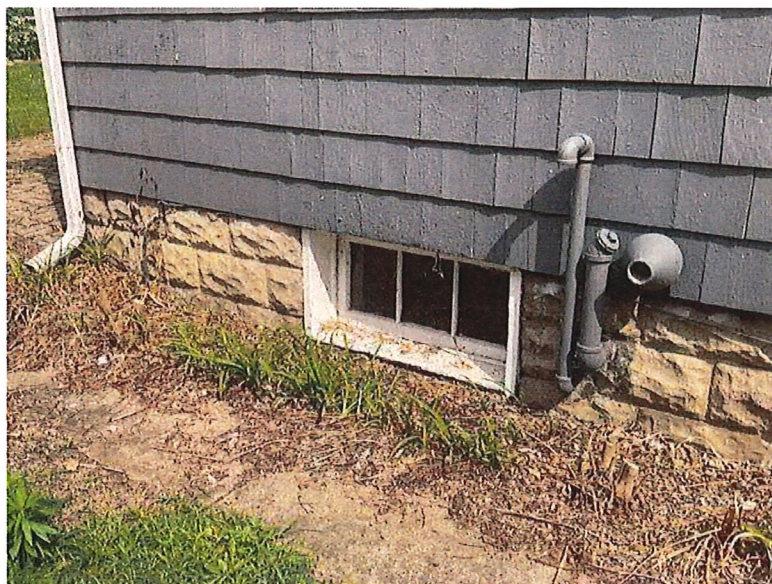
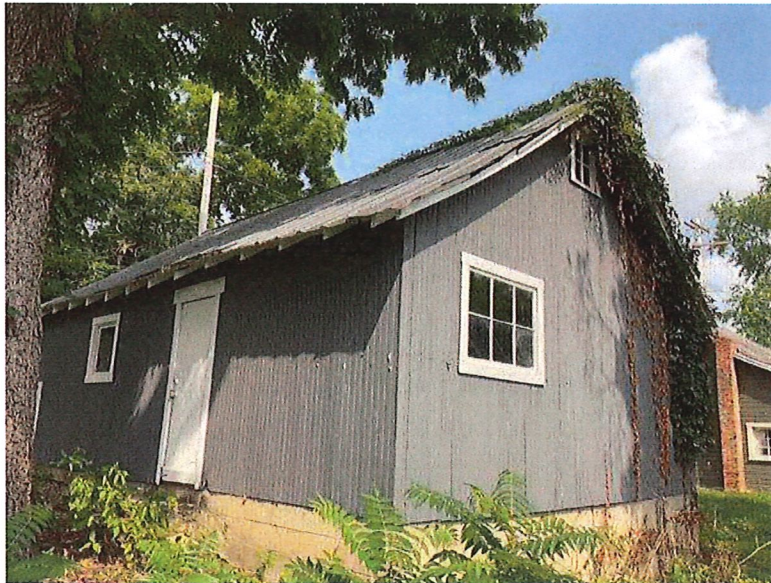
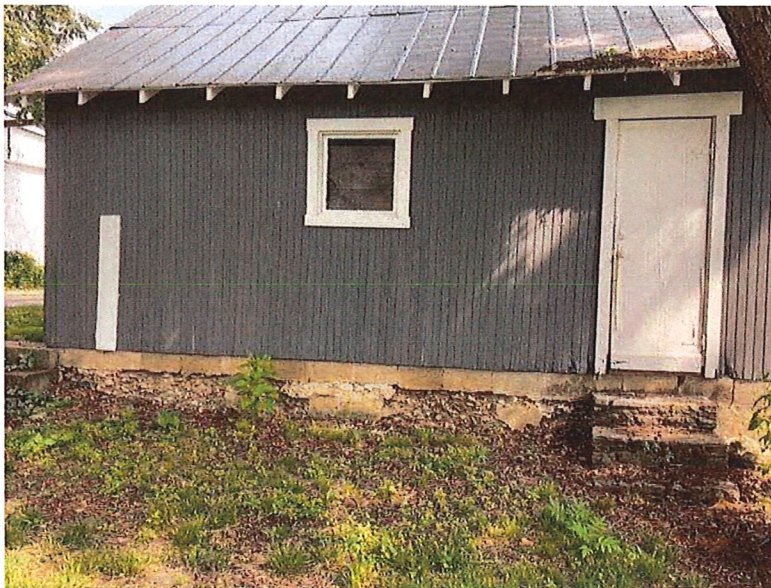
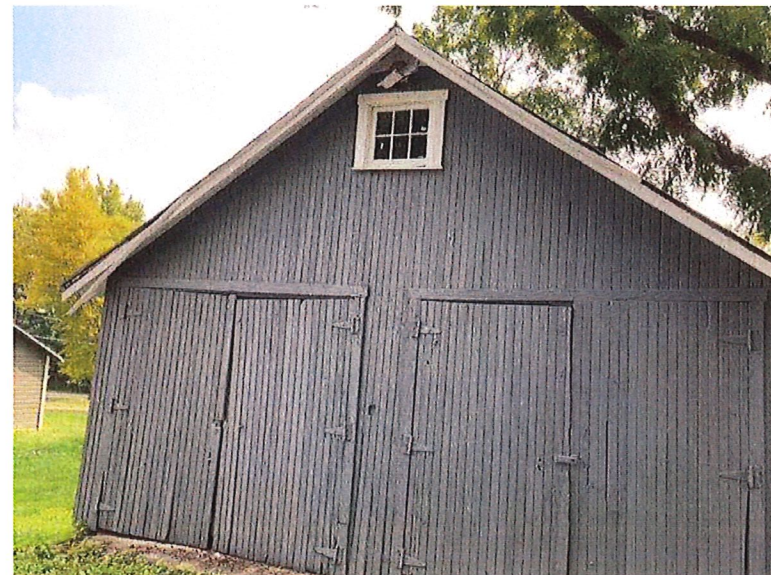
17 N Riverview

The chimney appears good (all chimneys and exhaust would need safety inspection along with the roof repairs). There is some visible wood rot at the roof line and at the foundation windows, but not significant. The front porch steps/railing and the rear masonry steps (no railing) are in poor condition. The accessory structure is in fair condition, with roof line and foundation damage.

Numerous photos of the specific areas of concern for this property follow. The immediate area of concern at transfer would be the roofs, gutters, windows and doors to ensure a weather tight seal (interior inspection could reveal current water damage). These would need to be abated within 30 days of transfer, or have contracts for repairs provided in that timeframe.

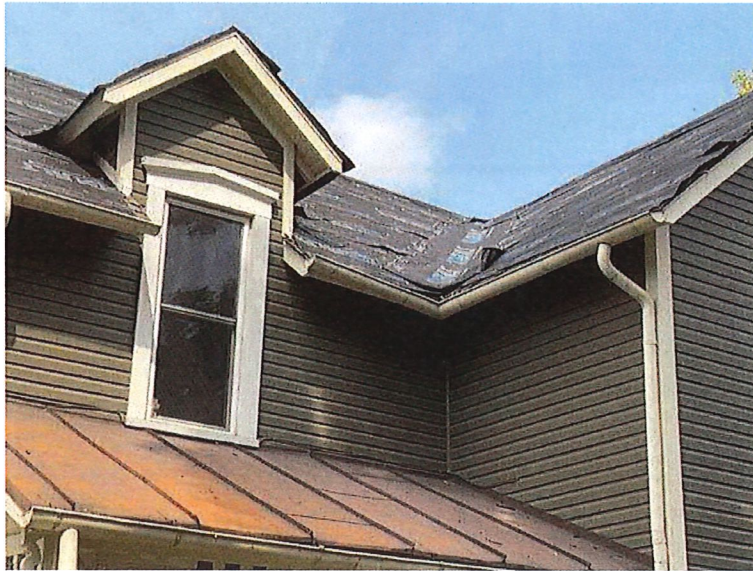
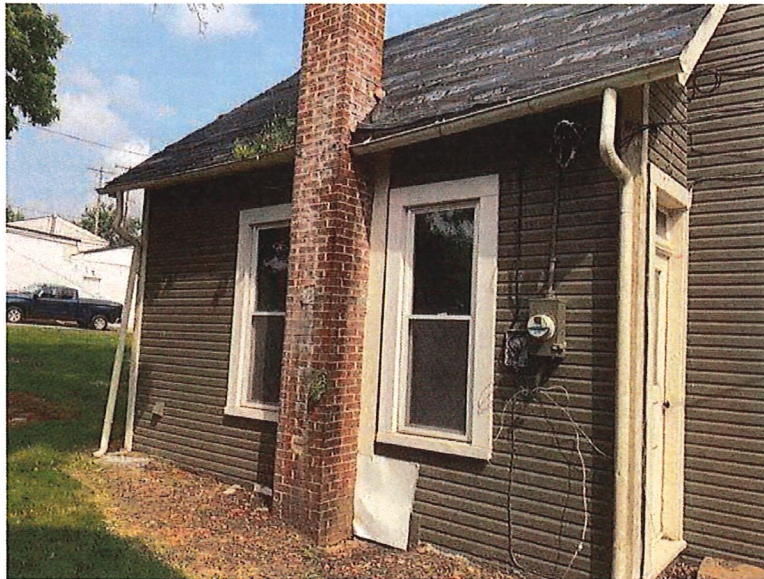
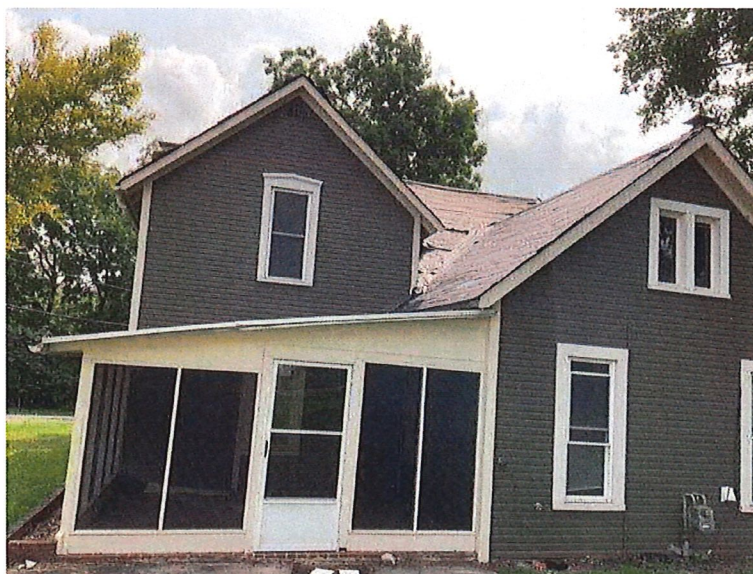
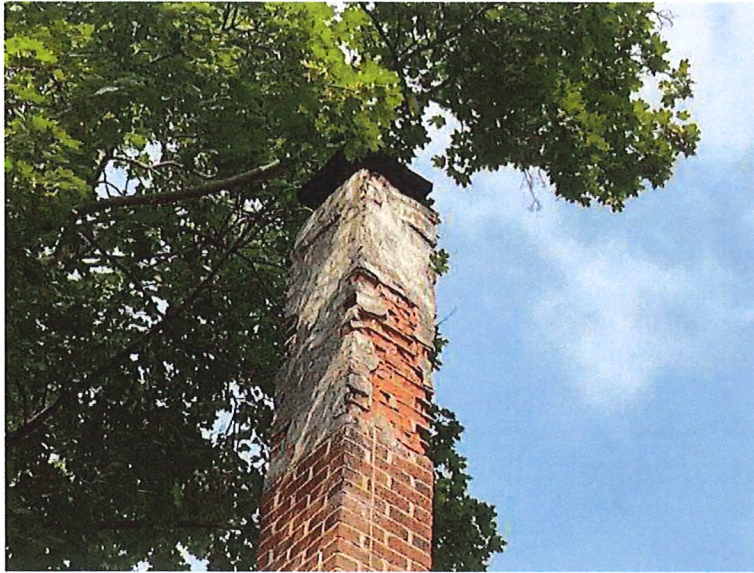
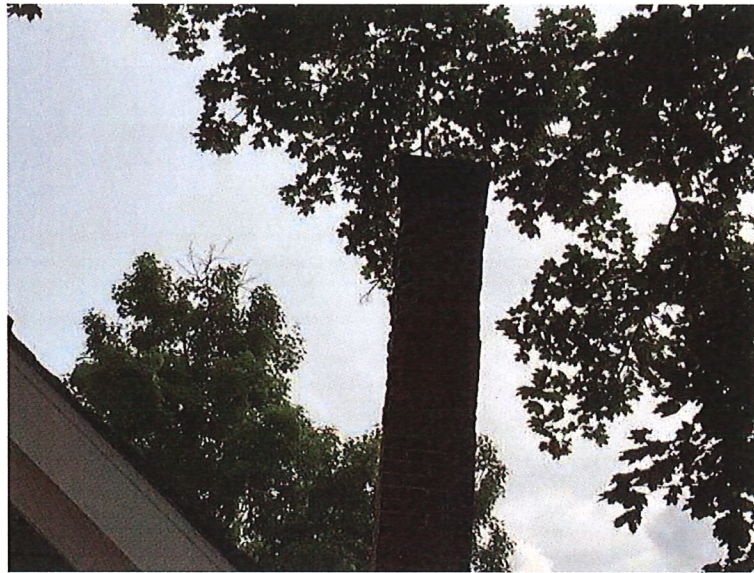
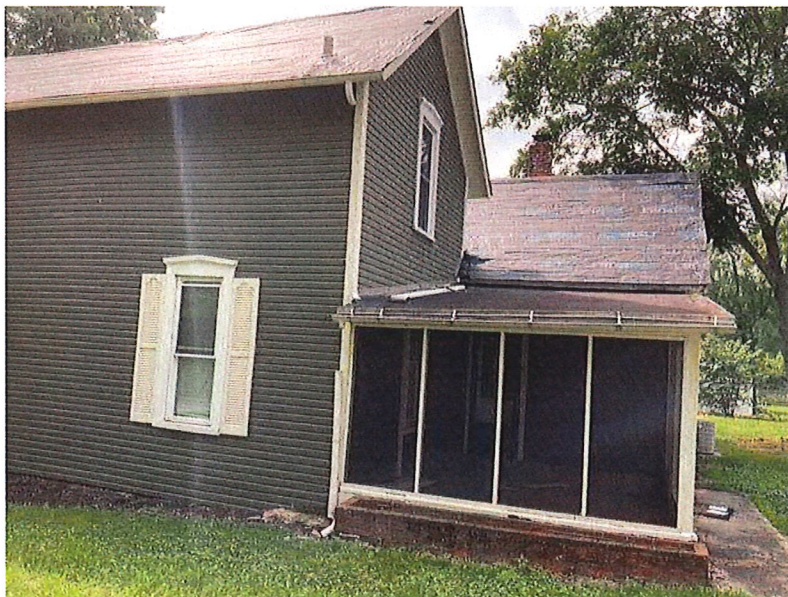
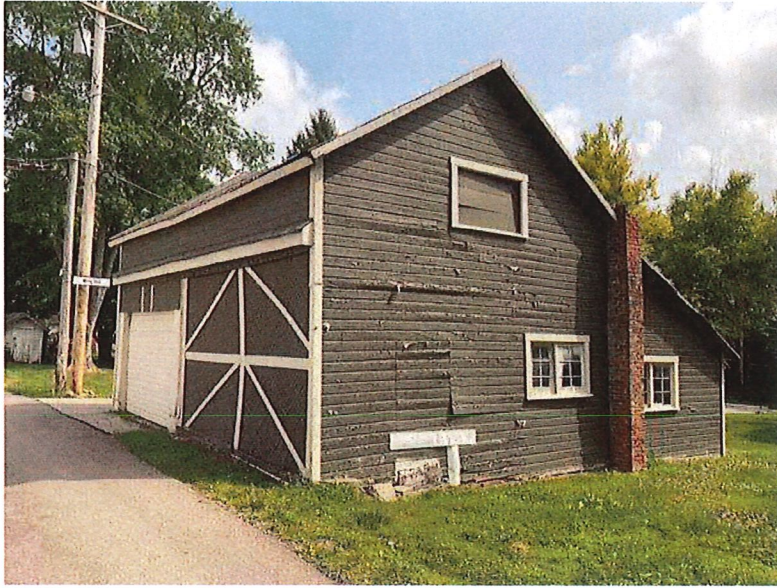
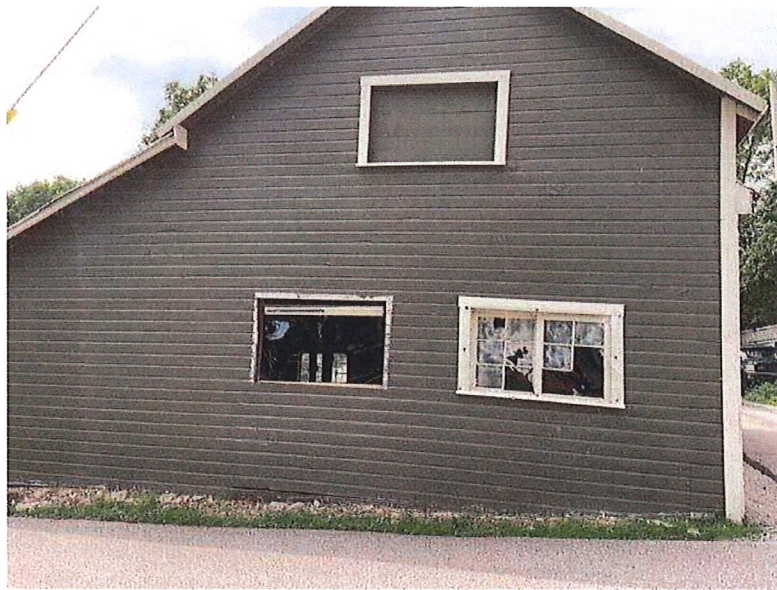
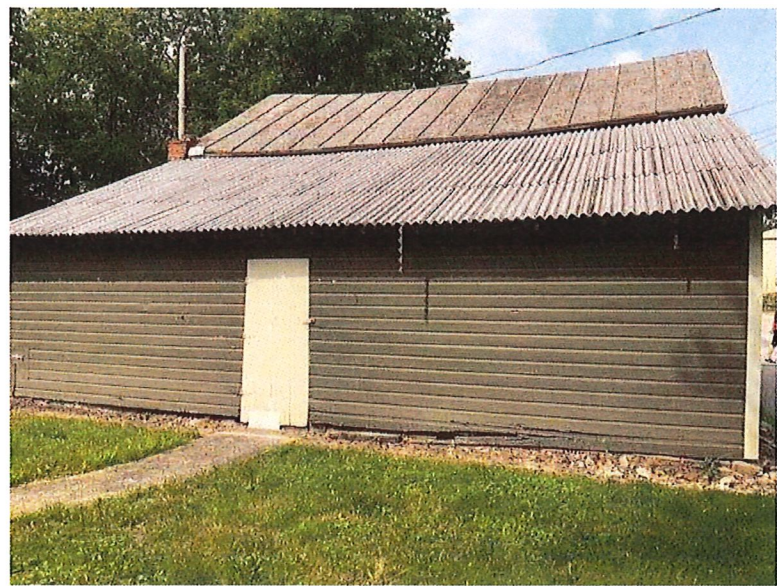
27 N Riverview

The chimney is in significant disrepair (all chimneys and exhaust would need safety inspection along with the roof repairs). Siding on the main structure appears in good condition, however the accessory structure has damage to the south and east faces, but is in fair condition overall.

Numerous photos of the specific areas of concern for this property follow. The immediate area of concern at transfer would be the roofs, gutters, windows and doors to ensure a weather tight seal (interior inspection could reveal current water damage). These would need to be abated within 30 days of transfer, or have contracts for repairs provided in that timeframe.

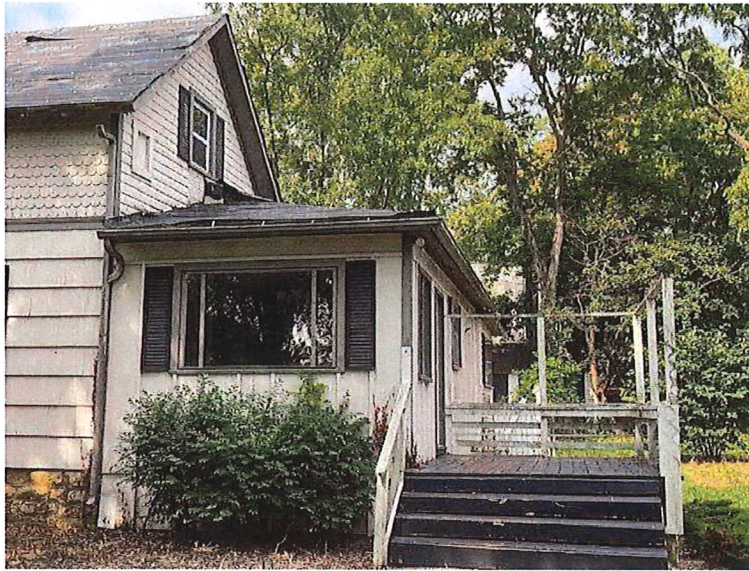
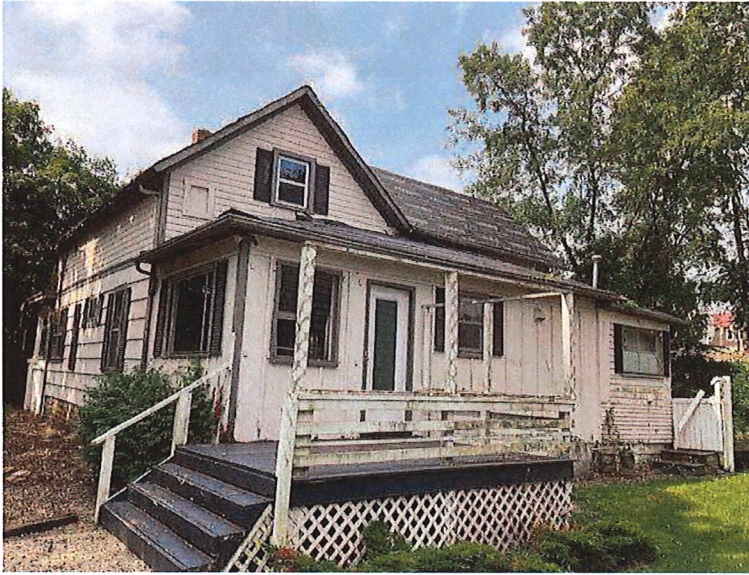
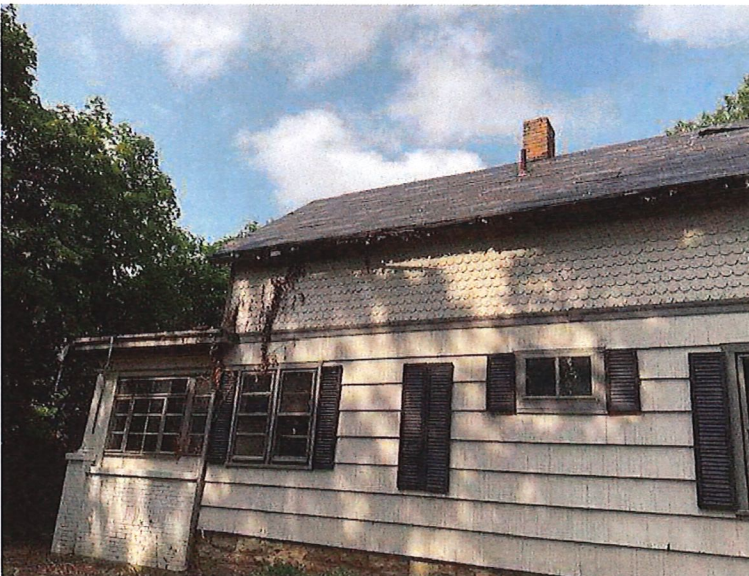
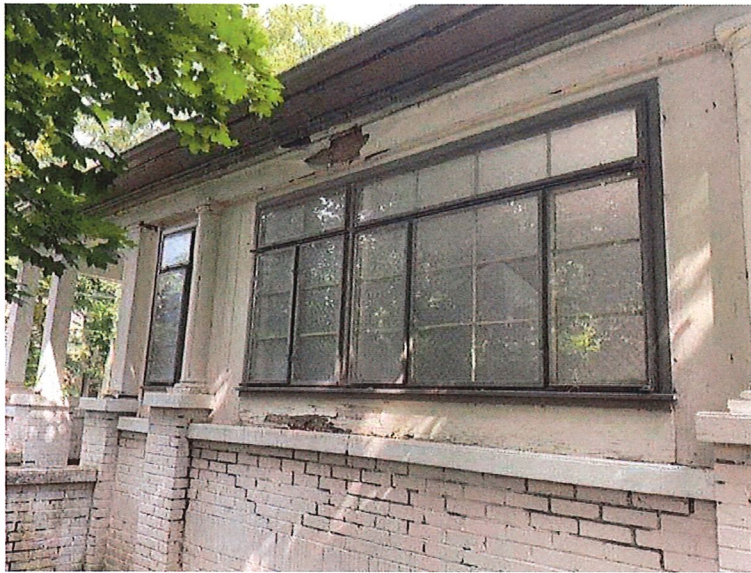
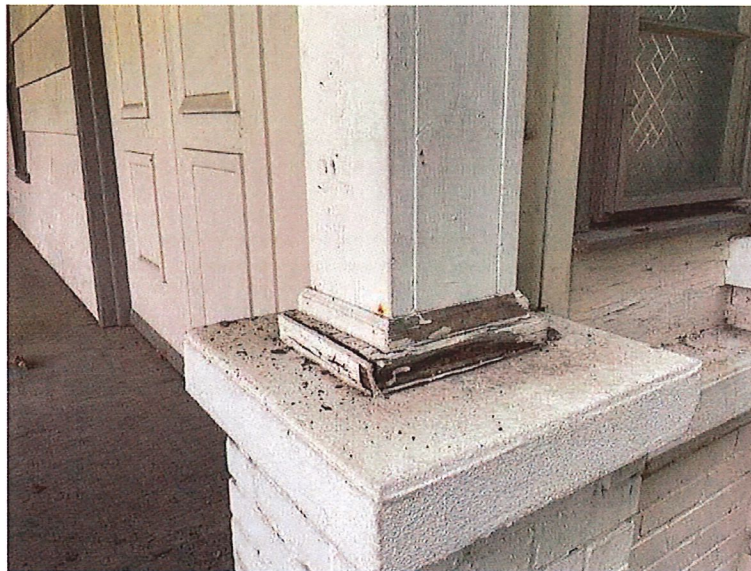
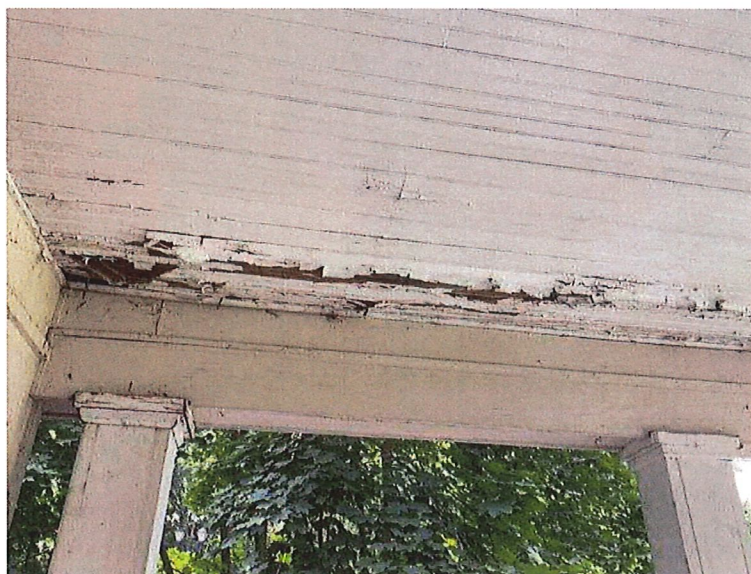
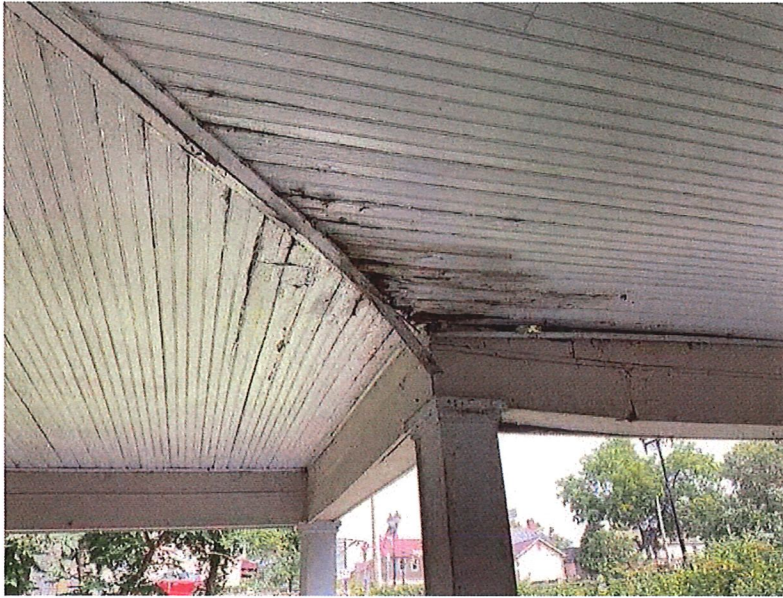
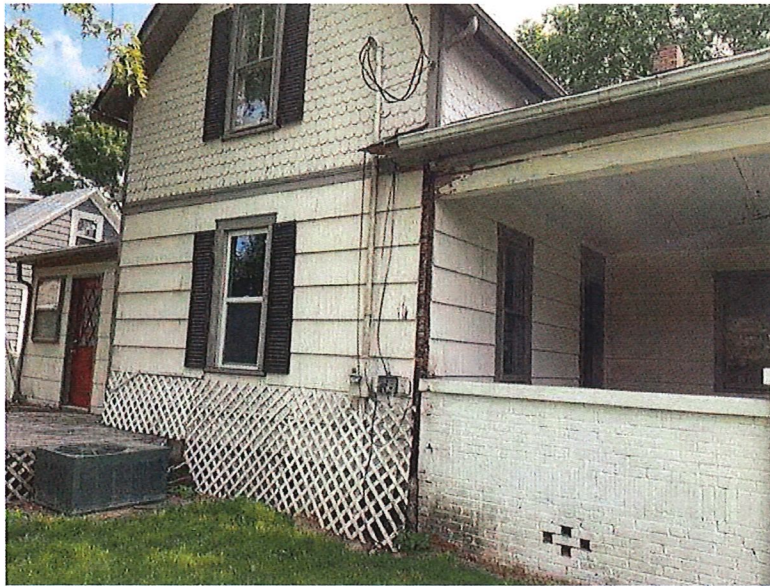
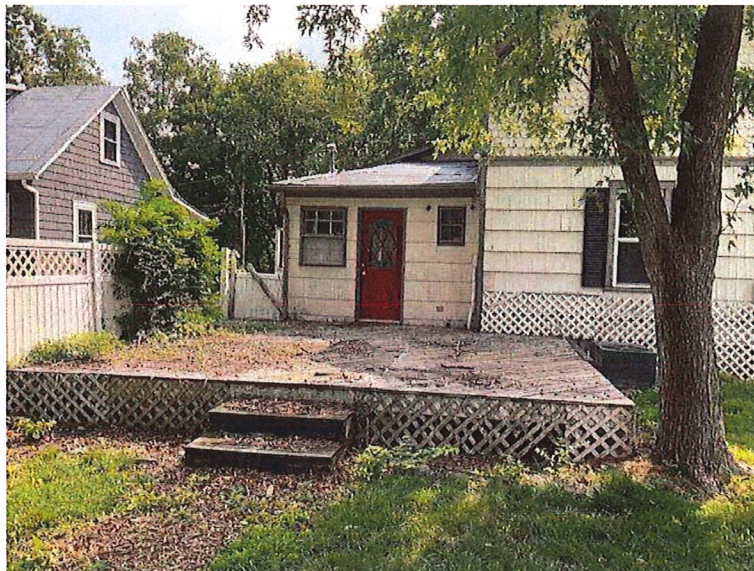
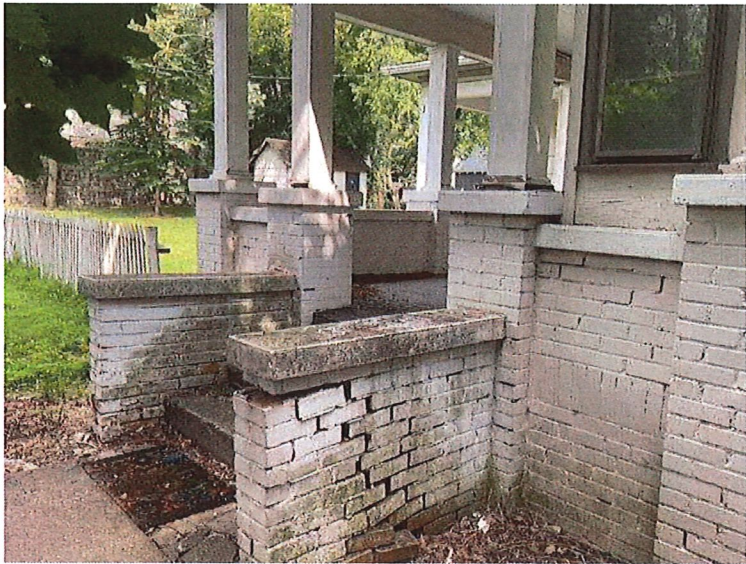
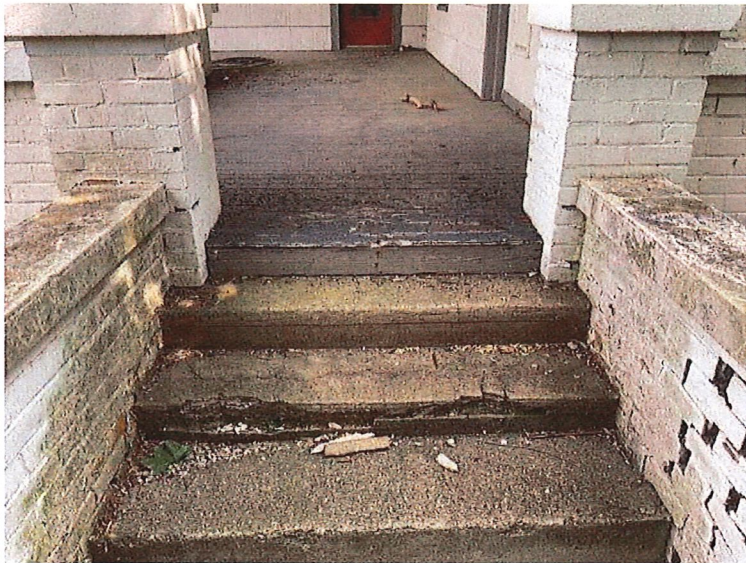
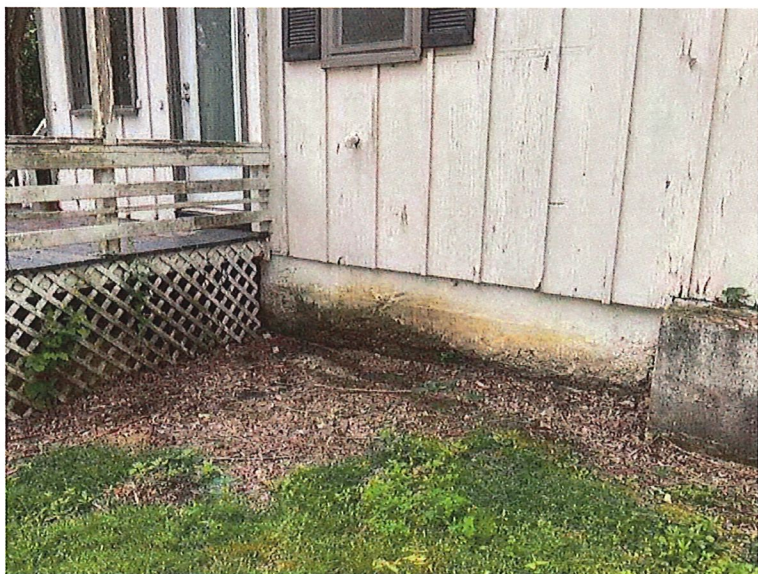
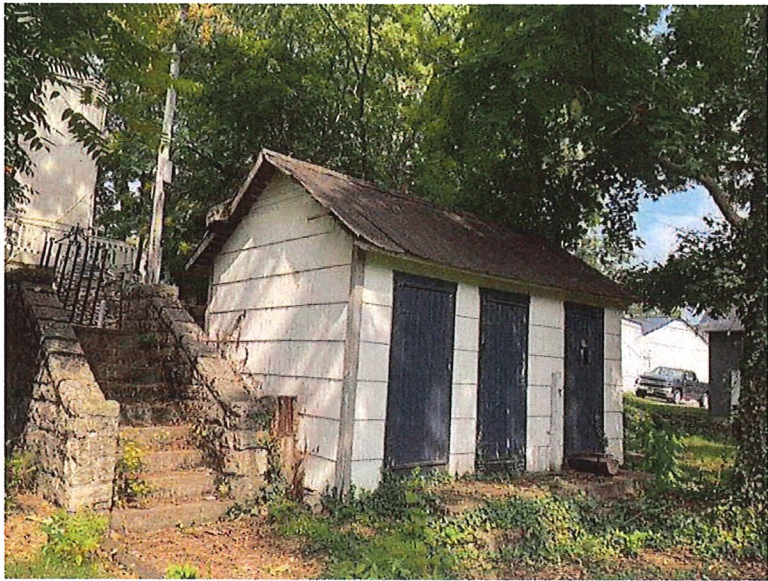
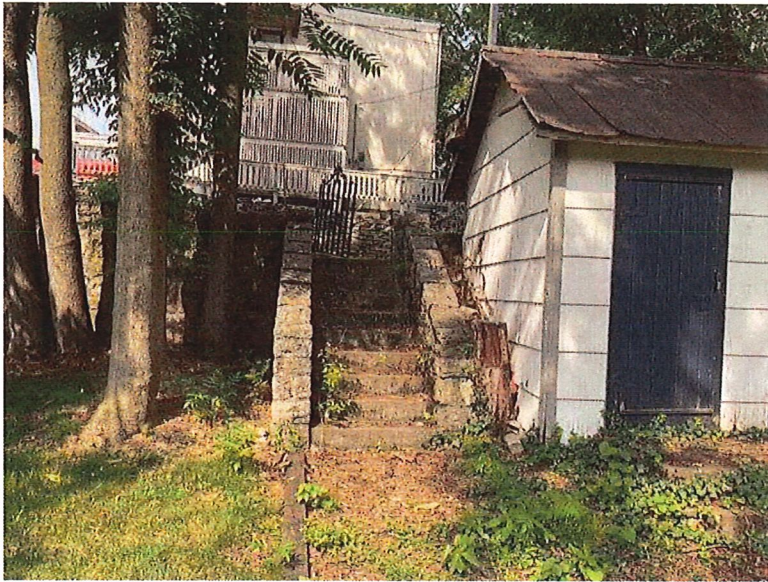
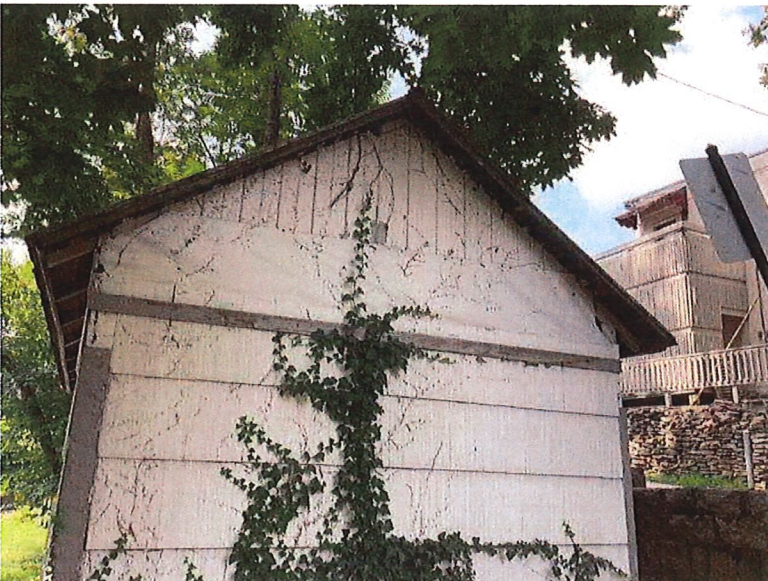
40 N Blacksmith

The chimney is in significant disrepair (all chimneys and exhaust would need safety inspection along with the roof repairs). There is visible wood rot on multiple areas at the roof line and at seams visible through siding gaps (removal of siding/lattice could reveal additional damage). The deck does not appear sound. The accessory structure is in fair to poor condition.

Numerous photos of the specific areas of concern for this property follow. The immediate area of concern at transfer would be the roofs, gutters, windows and doors to ensure a weather tight seal (interior inspection could reveal current water damage). These would need to be abated within 30 days of transfer, or have contracts for repairs provided in that timeframe.
