## APPENDIX G – Historic Stone Walls

## Stone Walls

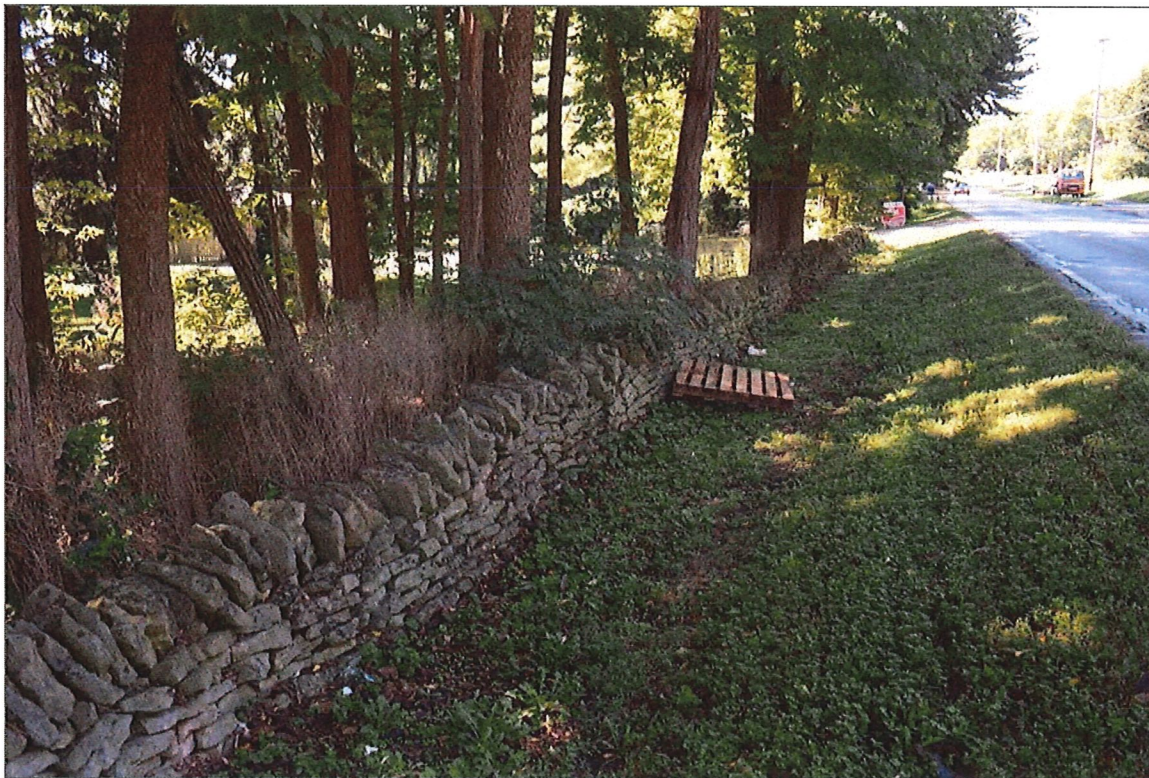
Surveyed traditional dry-laid stone walls are all very similar in appearance and construction, but vary in terms of the size of the limestone slabs used and overall dimensions. Walls were made of either small limestone slabs (under three inches thick and less than one foot long, as shown in Figure 92) or they were made from slabs of limestone that were larger (see Figure 93). It is suspected that the size of the stone in the vertical top course may be related to the age of the wall, either as the result of mechanical breakdown of the rock or changing

Figure 92. Example of lower wall with slightly smaller stones (Wall W033 along Riverside Drive, looking south)

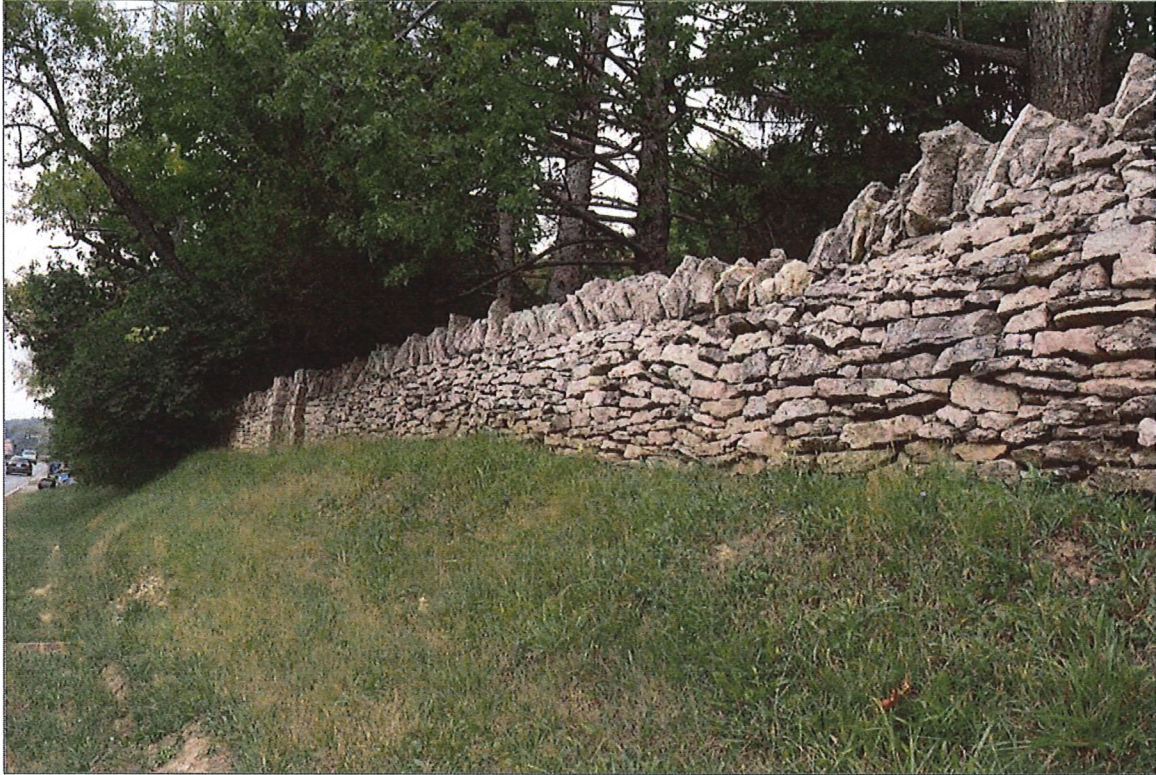
construction practices through time. Walls made with the smaller stones are typically no more than three feet in height. Walls made with the larger stones are wider and taller, averaging over three feet in height. This is an interesting difference in light of stone mason Eli Pinney's recollection that the walls were designed to fence cattle and were typically between 42 and 48 inches in height (Valentine and Bauer 2016). Pinney's description matches the description of nearly identical dry-laid stone walls found in Kentucky's Bluegrass region. Hart (1998:185) notes that stone livestock fences became more popular in the 1840s after timber had been depleted in the Bluegrass Region. The fences were typically five feet in height "with smooth sides that tapered from a width of three feet at the base to eighteen inches at the top" (Hart 1998:187). Hart (1998:187) also states that by the 1880s dry-laid stone walls became more expensive to construct and maintain because of labor costs so that their popularity diminished, except to those who could afford to construct them as status symbols. By the 1920s and 1930s many stone walls in the Kentucky Bluegrass region were removed so that roadways could be widened for the automobile (Hart 1998:187). It is possible that the difference in height among Dublin's stone walls is related to age or relocation. It may be that as walls deteriorated or were moved, they were not built as high because they no longer functioned as livestock fences. In conjunction with this practice of partially rebuilding walls, it is possible that only the top vertical courses were reset to maintain the original appearance of the walls. In Dublin, very few traditional dry-laid stone walls are missing the top vertical course. Some walls without this vertical top course appear to once have had it since the rest of the wall construction is the same as those walls with vertical top courses. It is also interesting to note that only a very few of the traditional dry-laid stone walls in Dublin have repairs or patches of cement along the lower courses, although some have had the top vertical course set in cement.

Figure 93. Example of taller wall with larger stones (Wall W005 along Riverside Drive, looking north)

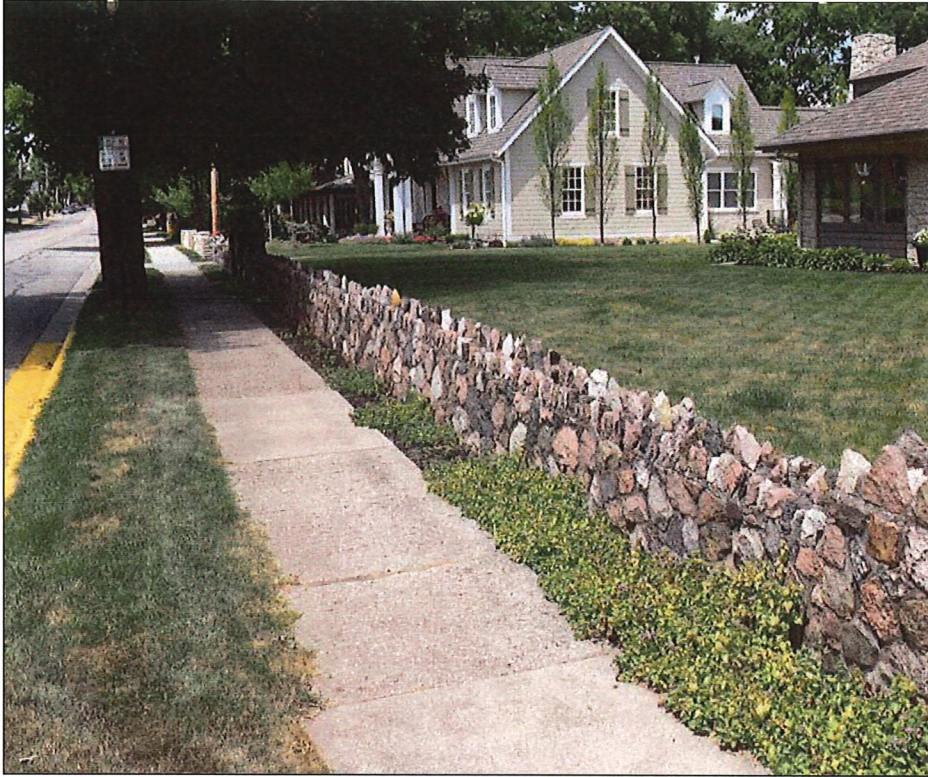
Dublin's atypical stone walls appear to be related to individual property owner's preferences rather than any larger trend. In general, these walls tend to be along residential property boundaries, are mortared, and may feature rounded rather than tabular stone. A greater diversity of raw material types is also common. Figure 94 depicts one of the atypical stone walls of Dublin.

Figure 94. Example of an atypical stone wall (W065A) in front of 824 S. High Street, looking northeast

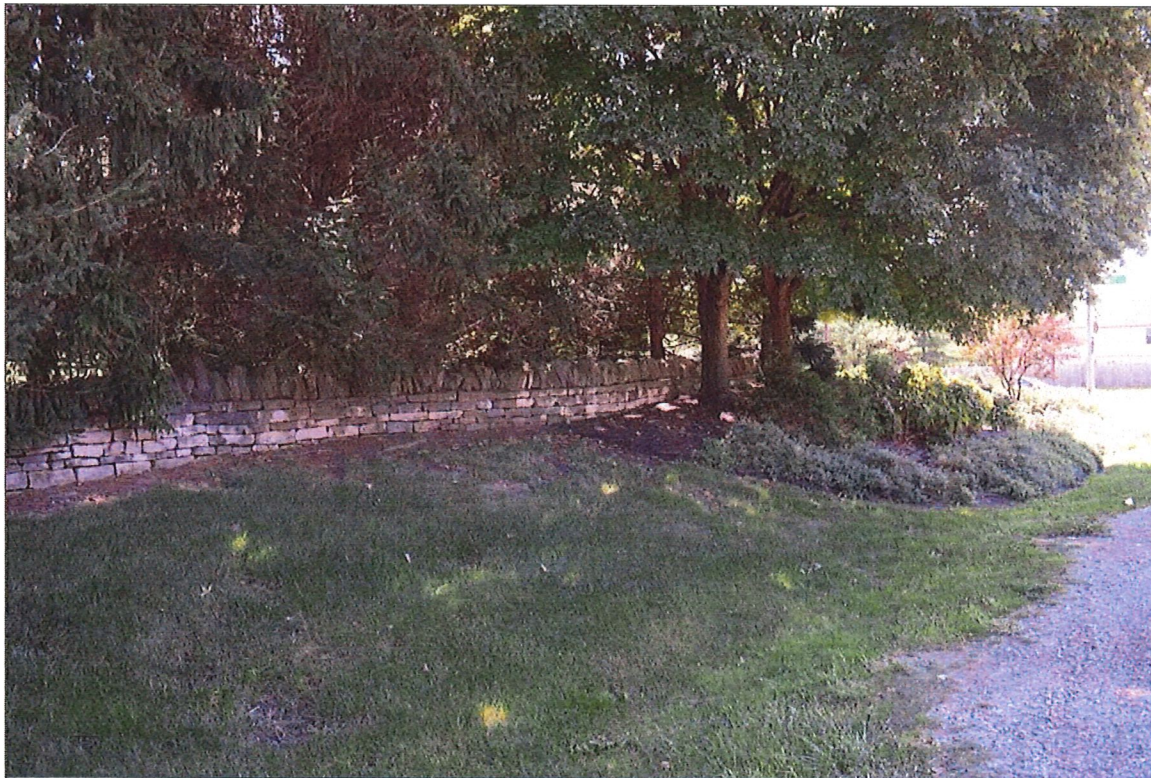
Walls built within the last 10 years tend to be of machine cut, square slabs, as depicted in Figure 95, and the walls built in 2016 as part of the trail project were constructed with mortar between the courses (Figure 96).

Figure 95. Modern wall with square, cut stones, near intersection of Dublin and Frantz Roads, looking southeast

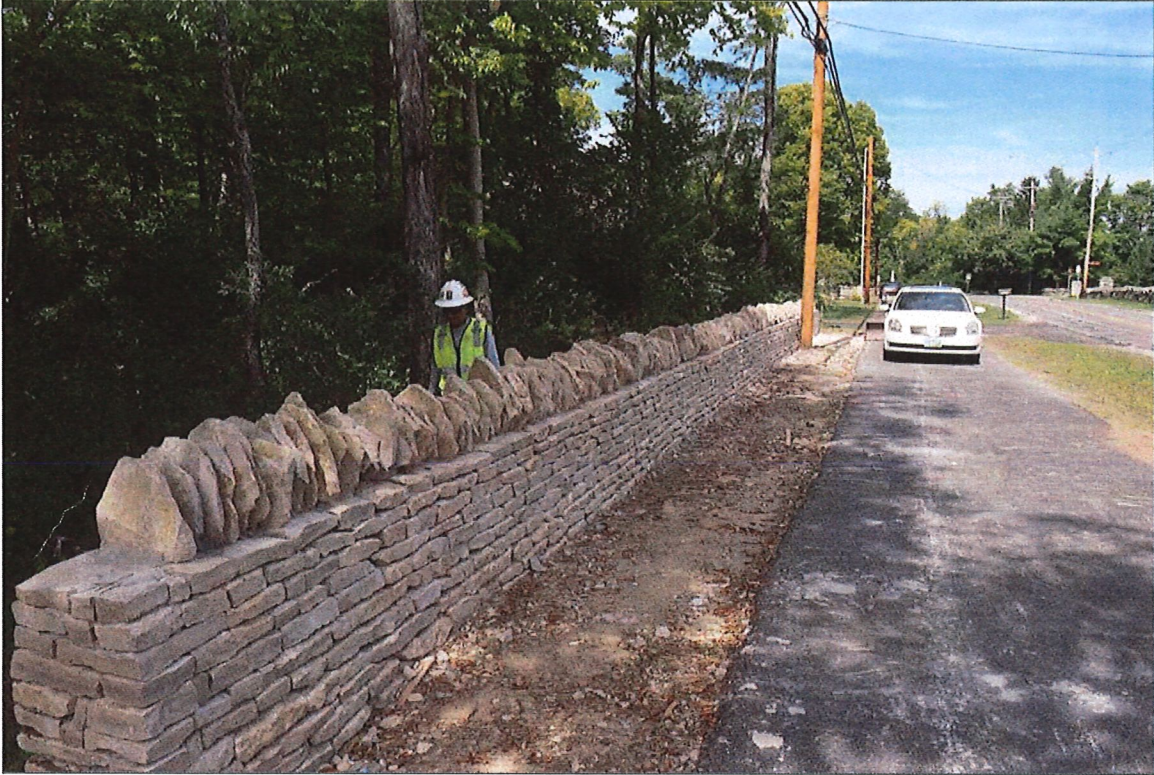
Figure 96. Wall in process of being rebuilt as part of trail project (W034 along west side of Dublin Road south of downtown, looking north). Note top course set in mortar.
