APPENDIX F – Code Enforcement List of Deficiencies

17 N Riverview Exterior Property Assessment – Code Enforcement

27 N Riverview Exterior Property Assessment – Code Enforcement

40 N Blacksmith Exterior Property Assessment – Code Enforcement

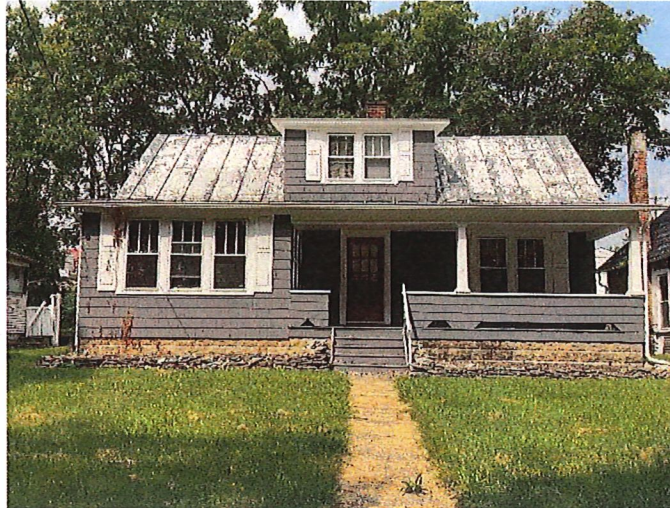
17 N Riverview

The following IMPC 2021 violations are apparent to some degree in this property:

- 302.3 Sidewalks & Driveways – Not in proper repair and free from hazardous conditions
- 302.7 Accessory Structures – Not maintained structurally sound and in good repair

- 304.2 Protective Treatment – Peeling and flaking paint, damaged siding and masonry
- 304.5 Foundation Walls – Not free from open cracks and breaks in masonry

- 304.6 Exterior Walls – Not free from holes, breaks and loose or rotting materials
- 304.7 Roofs & Drainage – Roof, drains, gutters and downspouts in poor repair

- 304.8 Decorative Features – Not maintained in good repair and not in safe condition
- 304.10 Stairways, Decks, Porches – Not maintained structurally sound or in good repair

- 304.11 Chimneys – Not maintained structurally sound and not in good repair
- 304.12 Handrails – Not to building code and not maintained in code condition

- 304.13 Windows/Door Frames – Not kept in sound condition and weather tight

The chimney appears good (all chimneys and exhaust would need safety inspection along with the roof repairs). There is some visible wood rot at the roof line and at the foundation windows, but not significant. The front porch steps/railing and the rear masonry steps (no railing) are in poor condition. The accessory structure is in fair condition, with roof line and foundation damage.

Numerous photos of the specific areas of concern for this property follow. The immediate area of concern at transfer would be the roofs, gutters, windows and doors to ensure a weather tight seal (interior inspection could reveal current water damage). These would need to be abated within 30 days of transfer, or have contracts for repairs provided in that timeframe.

While some of the additional issues noted could be abated in a 30-90 day timeframe, others could take much longer, likely involving permits and approvals for removal/modification.

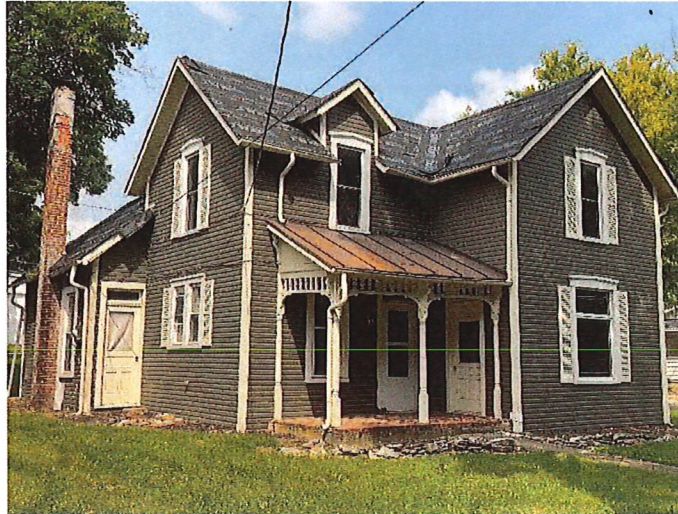
27 N Riverview

The following IMPC 2021 violations are apparent to some degree in this property:

- 302.3 Sidewalks & Driveways – Not in proper repair and free from hazardous conditions
- 302.7 Accessory Structures – Not maintained structurally sound and in good repair

- 304.2 Protective Treatment – Peeling and flaking paint, damaged siding and masonry
- 304.5 Foundation Walls – Not free from open cracks and breaks in masonry

- 304.6 Exterior Walls – Not free from holes, breaks and loose or rotting materials
- 304.7 Roofs & Drainage – Roof, drains, gutters and downspouts in poor repair

- 304.8 Decorative Features – Not maintained in good repair and not in safe condition
- 304.10 Stairways, Decks, Porches – Not maintained structurally sound or in good repair

- 304.11 Chimneys – Not maintained structurally sound and not in good repair
- 304.12 Handrails – Not to building code and not maintained in code condition

- 304.13 Windows/Door Frames – Not kept in sound condition and weather tight

The chimney is in significant disrepair (all chimneys and exhaust would need safety inspection along with the roof repairs). Siding on the main structure appears in good condition, however the accessory structure has damage to the south and east faces, but is in fair condition overall.

Numerous photos of the specific areas of concern for this property follow. The immediate area of concern at transfer would be the roofs, gutters, windows and doors to ensure a weather tight seal (interior inspection could reveal current water damage). These would need to be abated within 30 days of transfer, or have contracts for repairs provided in that timeframe.

While some of the additional issues noted could be abated in a 30-90 day timeframe, others could take much longer, likely involving permits and approvals for removal/modification.

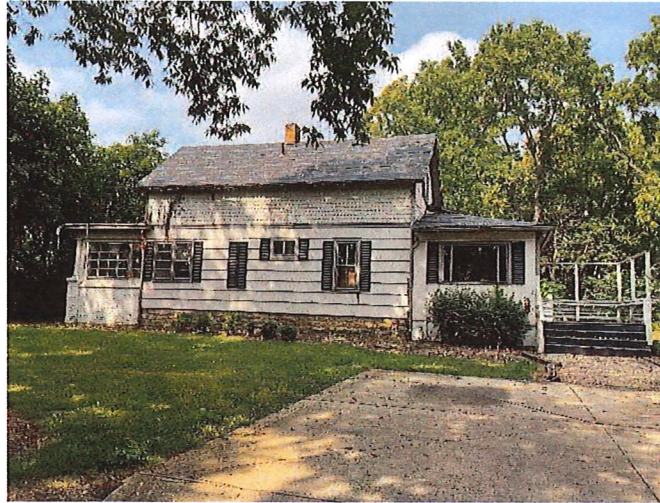
40 N Blacksmith

The following IMPC 2021 violations are apparent to some degree in this property:

- 302.3 Sidewalks & Driveways – Not in proper repair and free from hazardous conditions
- 302.7 Accessory Structures – Not maintained structurally sound and in good repair

- 304.2 Protective Treatment – Peeling and flaking paint, damaged siding and masonry
- 304.5 Foundation Walls – Not free from open cracks and breaks in masonry

- 304.6 Exterior Walls – Not free from holes, breaks and loose or rotting materials
- 304.7 Roofs & Drainage – Roof, drains, gutters and downspouts in poor repair

- 304.8 Decorative Features – Not maintained in good repair and not in safe condition
- 304.10 Stairways, Decks, Porches – Not maintained structurally sound or in good repair

- 304.13 Windows/Door Frames – Not kept in sound condition and weather tight
